Technical Background Report  
to the Safety Element of the La Quinta  
2035 General Plan Update  
Seismic Hazards, Geologic Hazards, Flooding Hazards

**TECHNICAL BACKGROUND REPORT to the  
SAFETY ELEMENT  
of the**

**TECHNICAL BACKGROUND REPORT TO THE SAFETY ELEMENT UPDATE  
CITY of LA QUINTA, CALIFORNIA**

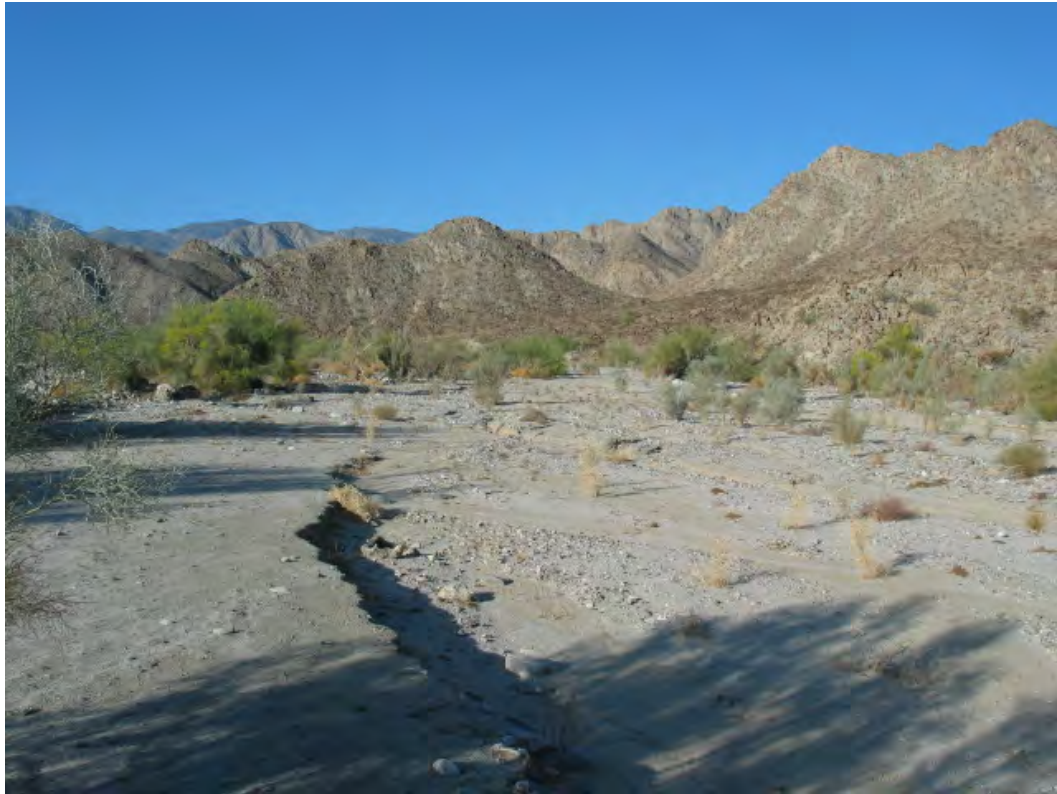
**Figure 3-1: Alluvial Fan Outwash from the Rugged Santa Rosa Mountains near La Quinta**

and sheet flow (Figure 3-1). Numerous drainages from the adjacent Santa Rosa Mountains flow toward La Quinta; the most significant of these in terms of flood hazard are Bear Creek and Devil Canyon. La Quinta has numerous facilities in place that have greatly reduced the potential for flooding in the city from these and other sources.
